**AN EVALUATION OF BENEFITS OF  
BUILDING COMMISSIONING ON CAPITAL PROJECTS  
AT VIRGINIA TECH**

**PROJECT & REPORT**

**MASTER OF SCIENCE  
IN  
BUILDING CONSTRUCTION**

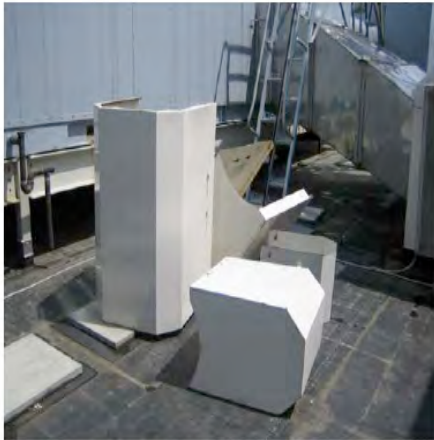
**Figure 7:** Original Fan Covers –  
“Totally Enclosed-Fan Cooled”

Once the problems with the exhaust system were identified, corrective actions were taken. The covers on the fan motors were replaced, allowing for cooling air flow. Figure 7 shows the original covers installed on the fans, and the motor with the replacement cover is shown in Figure 8 .

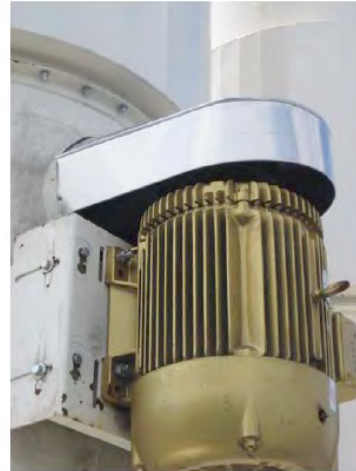
**Figure 8:** Fans with new cover in place
